# B Structural Steel and Steel Connections

## B.1 Structural Steel

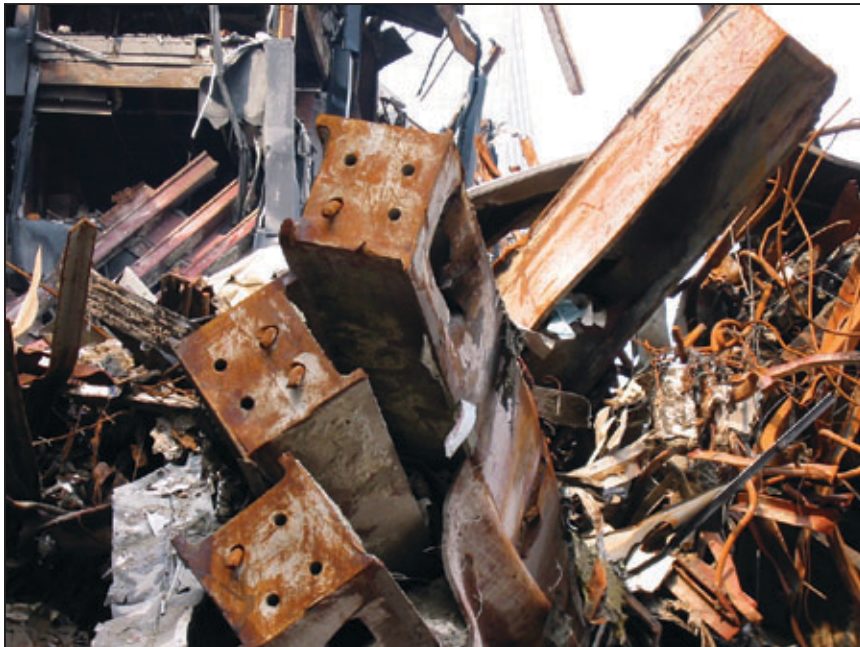
Figure B-1 Exterior column end plates.

sections were prefabricated into trees. These trees were three columns wide and one to three stories high. The cross-sectional shape of the columns can be seen in Figure B-1. These varied in length from 12 feet 6 inches to 38 feet, depending on the plate thickness and location.

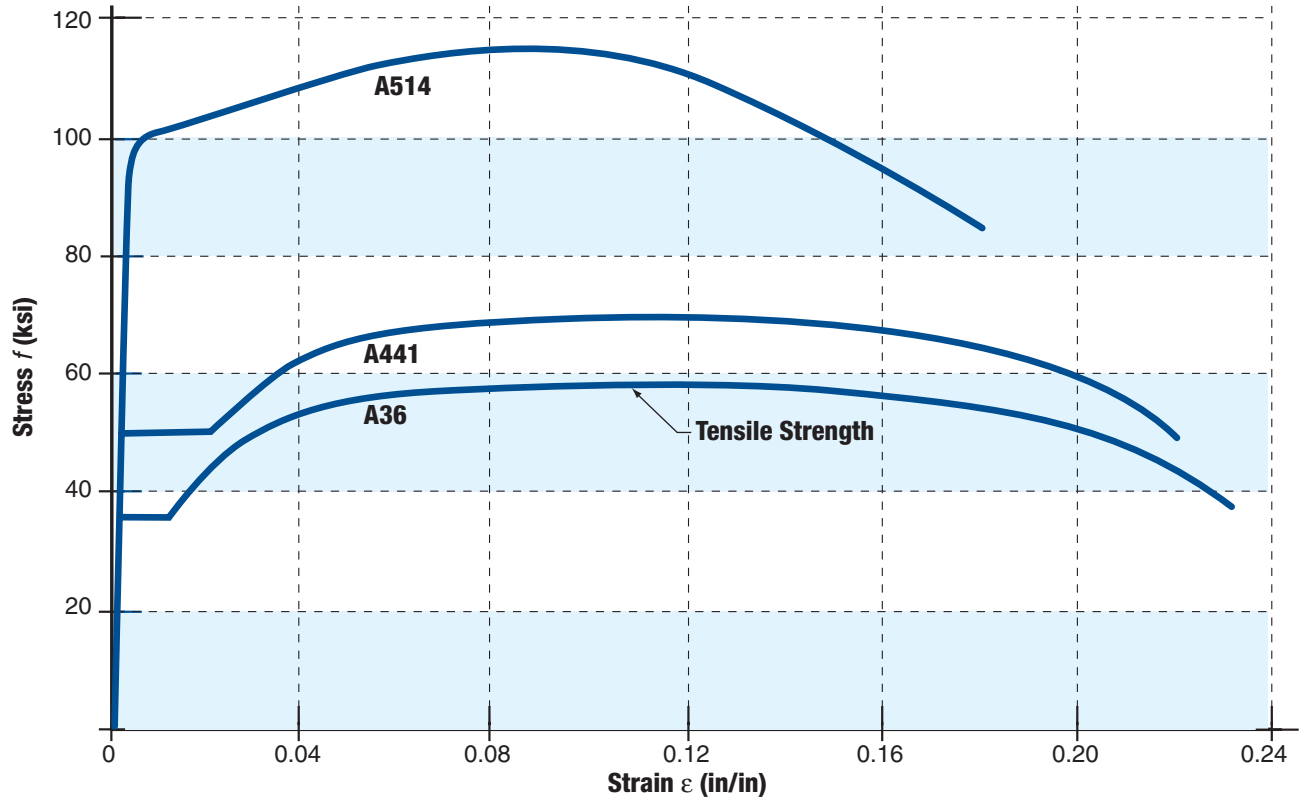
Figure B-2 Tensile stress-strain curves for three ASTM-designation steels (Brockenbrough and Johnston 1968, Tall 1974).

In lieu of actual WTC steel properties, typical stress-strain curves characteristic of 3 of the 12 steels used in the design and construction of the WTC complex are shown in Figure B-2 for three ASTM-designation steels with minimum specified yield strengths of 36 ksi (A36), 50 ksi (A441), and 100 ksi (A514). In general, as the yield strength of the steel increases, the yield-to-tensile-strength ratio (Y/T) also increases. For A36 steel, Y/T is approximately 0.6, whereas for A514 steel, Y/T is approximately 0.9. The yield plateau for five steels (yield points 36, 50, 65, 80, and 100 ksi) can be highly variable for structural steels, as is apparent from a comparison of the expanded initial portions of the five steels shown in Figure B-3. At the higher yield strength associated with quenched and tempered alloy steels, there may not be a distinct yield plateau; instead, the steels exhibit gradual yielding and nonlinear behavior with strain hardening.

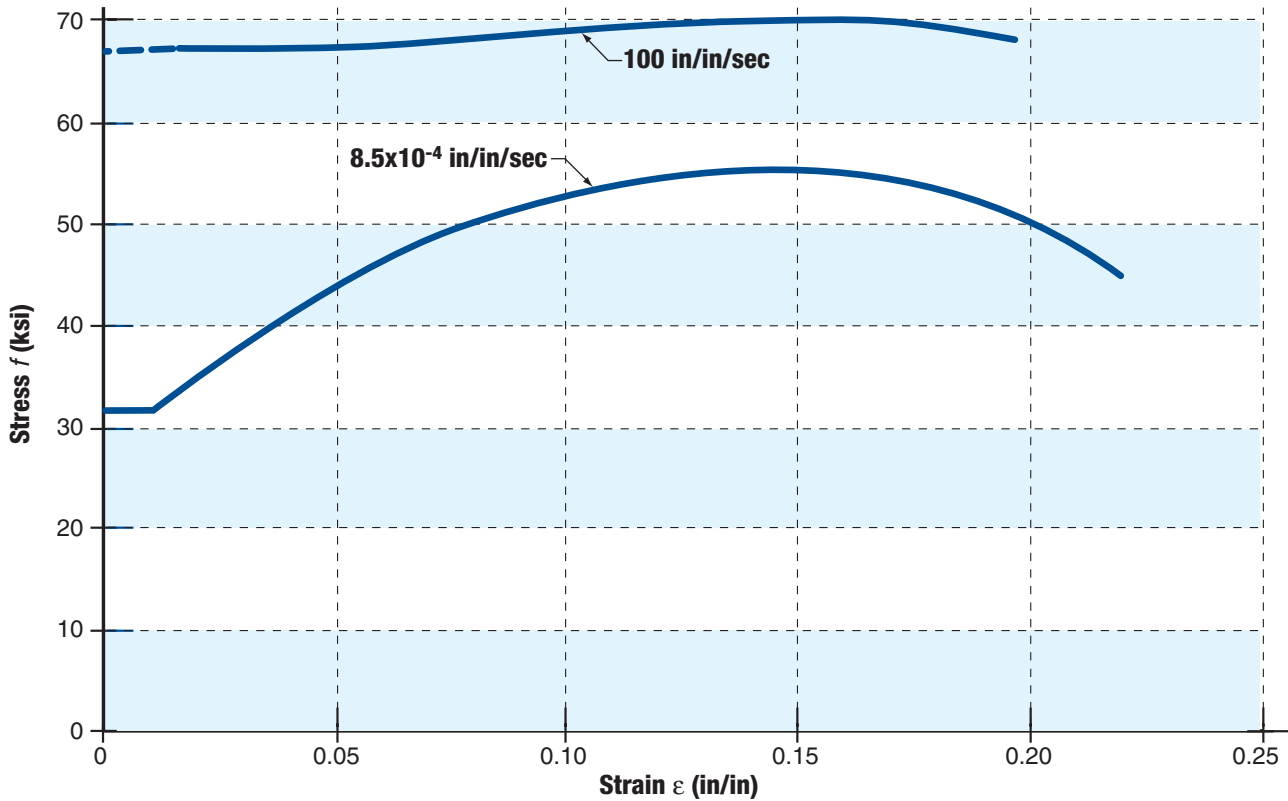
Figure B-4 Effect of high strain rate on shape of stress-strain diagram (Tall 1974).

High strain rates tend to increase the observed yield strength and tensile strength of steel, but may also reduce the ductility. There is a greater influence on the yield point than on the tensile strength. Figure B-4 compares the effect of a very high strain rate (100 in/in/sec) for a mild carbon steel with a more usual test speed of 850 micro in/in/sec. In this example, the yield point more than doubled, whereas the tensile strength was increased about 27 percent, and the Y/T ratio approached unity.

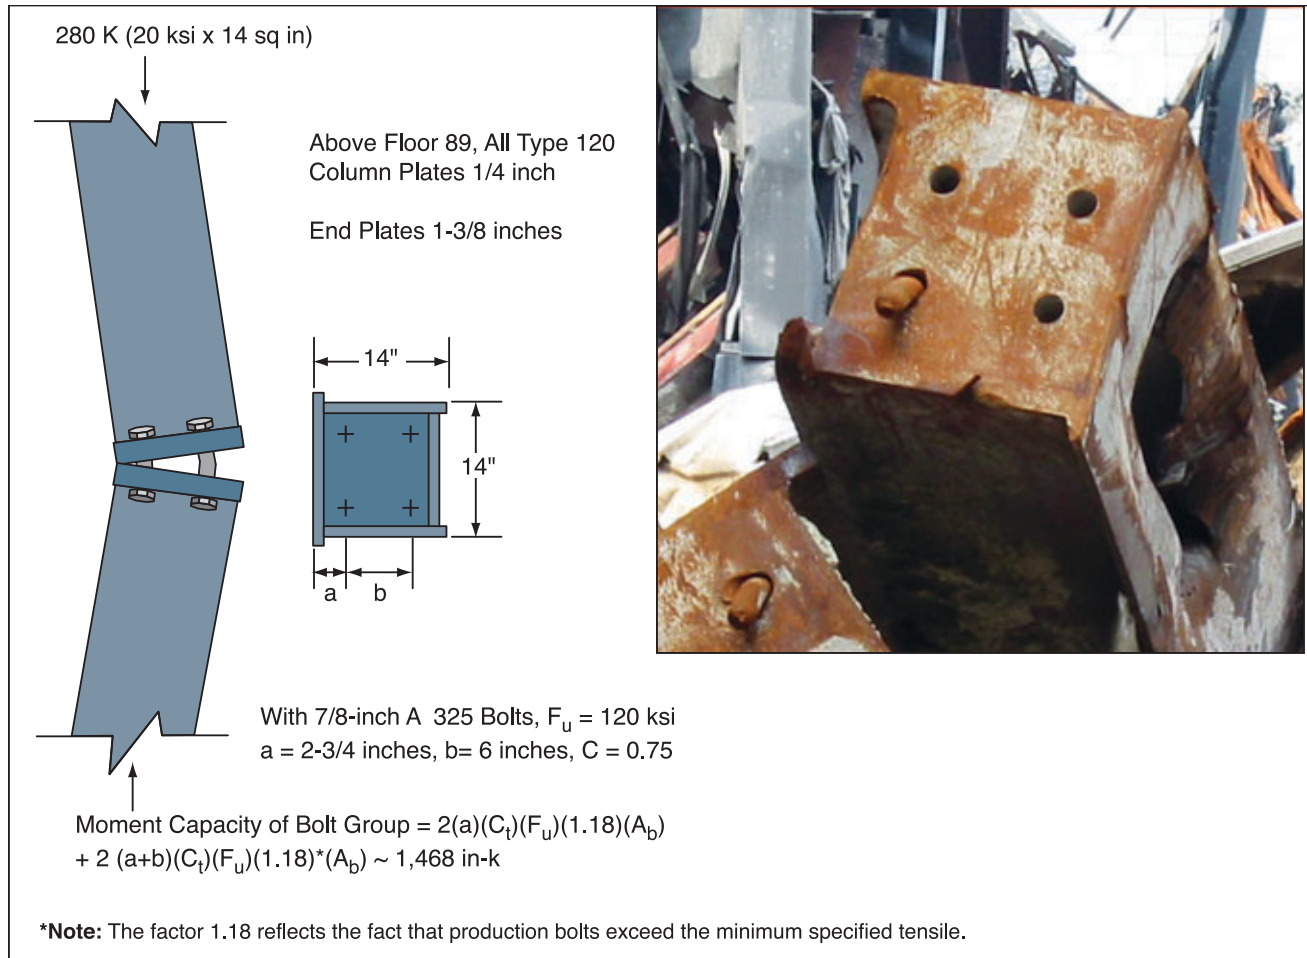
Figure B-7 Bent and fractured bolts at an exterior column four-bolt connection.

Collapse of the WTC towers resulted in failure of many of the bolts in bolted end plate connections as the columns were subjected to large and unanticipated out-of-plane bending. In the majority of cases, the A325 high-strength bolts reached their tensile capacity and failed in the threaded stress area. The example shown in Figure B-7 examines the flexural capacity of the bolted end plate in a column in the impact area where the column plate thickness was 1/4 inch.

The simple moment capacity of the bolt group is 20 to 30 percent of the plastic moment capacity of a column fabricated from steels with a 50 to 100 ksi yield point, assuming no axial load in the columns. The end plates at the columns splice have a 11-3/4-inch x 14-inch cross-section. The columns are subjected to axial load from the dead load acting on the structure. For the as-built structure, the moments acting on the bolted splice are small, because the splices were located at the column inflection points and the resultant of the applied axial load and moment is within the middle third of the 12-inch-deep bearing connection. Assuming an axial stress of 20 ksi in the column, the corresponding axial force acting on the base plate is 280 kips. As the columns lose lateral support and deform out-of-plane from overloading eccentricities and from the thermal effects, the bending moment acting on the column splice does not introduce significant forces into the bolted end plate connection until the eccentricity exceeds 2 inches. As the eccentricity increases, the applied bending moment will exceed the bolt preload stress when the eccentricity reaches approximately 4 inches. Continued deformation will exceed the ultimate moment capacity of the connection and result in instability as the eccentricity approaches 4.5 inches.

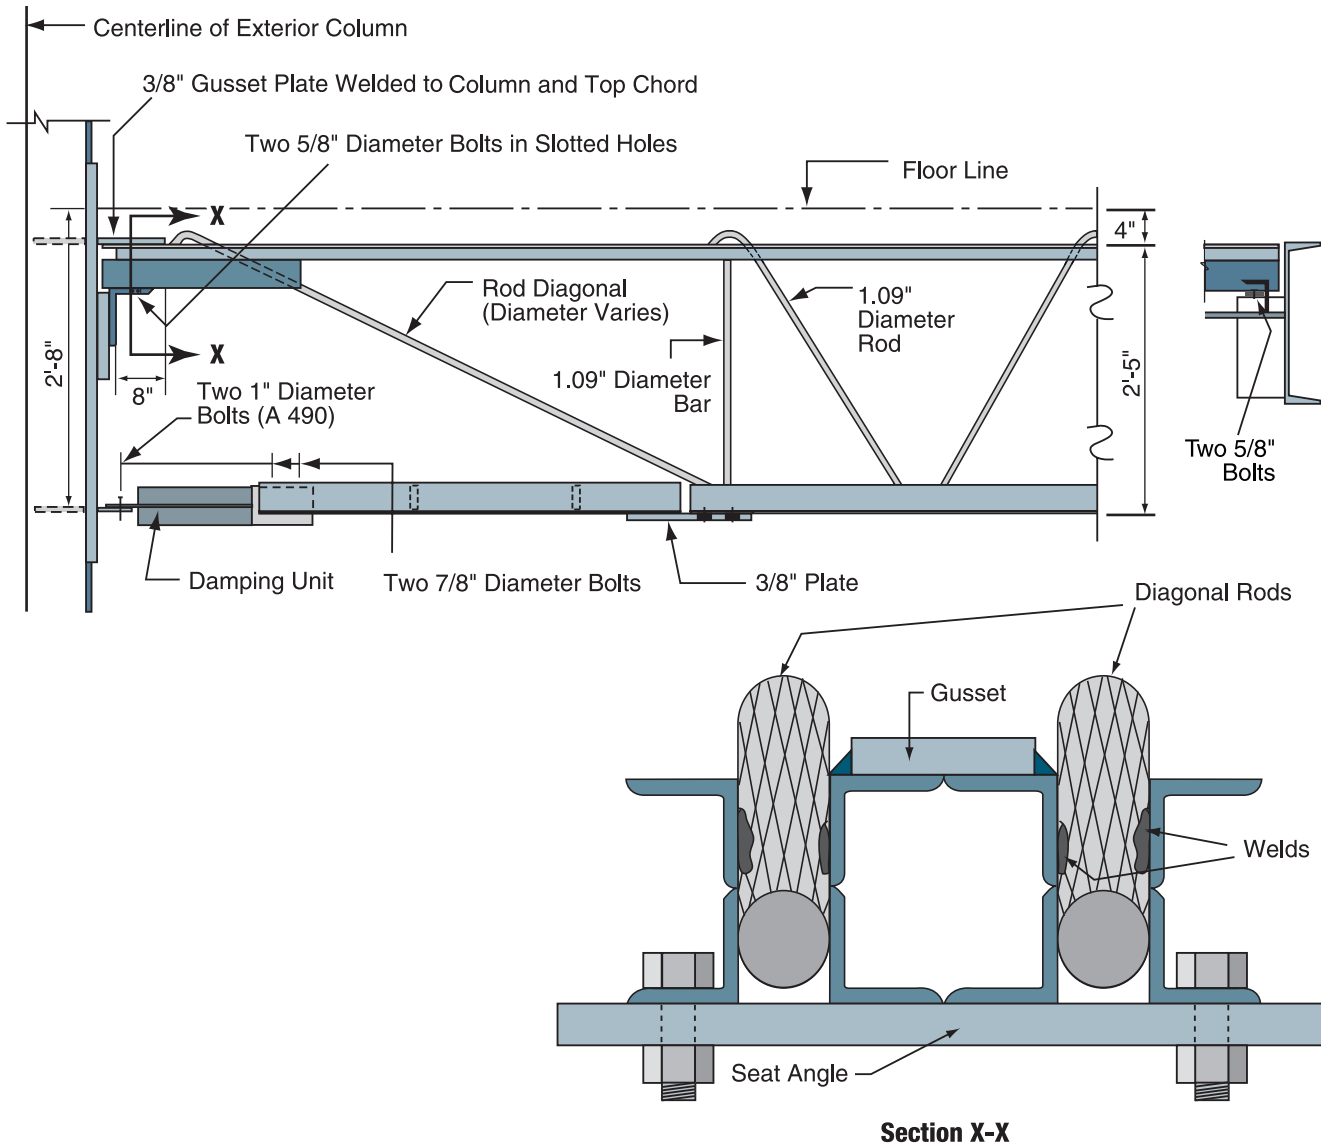
Figure B-8 Typical truss top chord connections to column/spandrel beam and to the core beam.

Figure B-8 shows the end of the top chords that were connected to every other exterior column/spandrel beam and the core support channel beams. The top chords were supported on bearing seats at each end of the two trusses. At the exterior column/spandrel beam, a gusset plate was groove-welded to the spandrel face and fillet-welded to the top chord angles. At the bearing seat, two 5/8-inch A325 bolts in 3/4-inch x 1-1/4-inch slotted holes connected the trusses' top chords to the bearing seat with a single bolt in the exterior angle of each truss. The lower chord was attached to the exterior column/spandrel beam with a visco-elastic damping unit connected to a small seat with two 1-inch A490 bolts that provided a slip-resistant connection. The damping unit had a capacity of about 5 kips.

At the core, the top chords were supported by bearing seats with two vertical stiffeners. Two 5/8-inch A325 bolts were installed in 3/4-inch x 1-3/4-inch slotted holes in the seat plate and standard holes in the top chord outside angles.

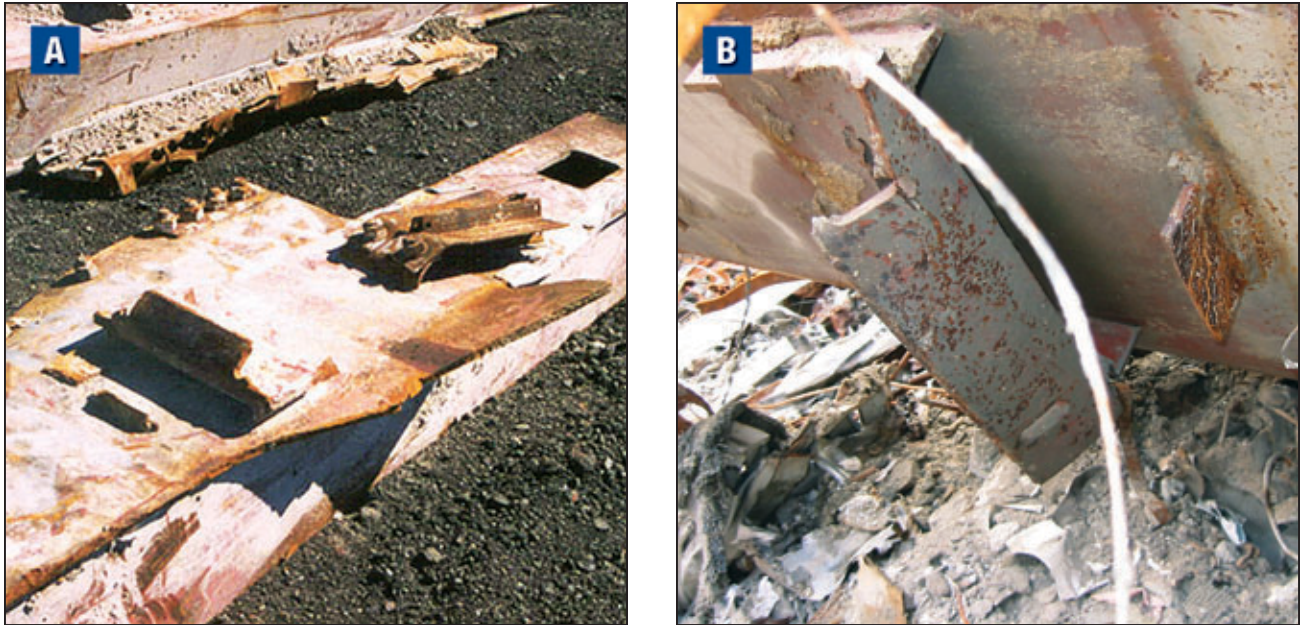
Figure B-9 (A) Visco-elastic damper angles bolted to angle welded to spandrel plate and (B) failed bearing seat connection.

Figure B-9 shows several of the failure modes of the truss connections to the chord bearing seat and spandrel beam. The gusset plate welded to the spandrel beam and the top chord failed by tensile fracture of the plate. The gusset plate connection was primarily resisting the floor diaphragm support to the column. After fracture, the slotted holes in the seat would allow rigid body motion of the trusses until the 5/8-inch bolts came into bearing. That resulted in partial fracture in the seat of the fillet welds attaching the fill plate to the spandrel beam. The seat angle welded connection to the fill plate remained intact as this separation occurred and final block shear failure developed in the outstanding angle leg at the two slotted bolt holes.

It is probable that, once the 3/8-inch gusset plate fractures, the next lower bound resistance is provided by the bearing capacity of the two 5/8-inch bolts on the beam seat angle. This failure also tore off the ends of the angle even though the tensile capacity of those segments was predicted to be higher.

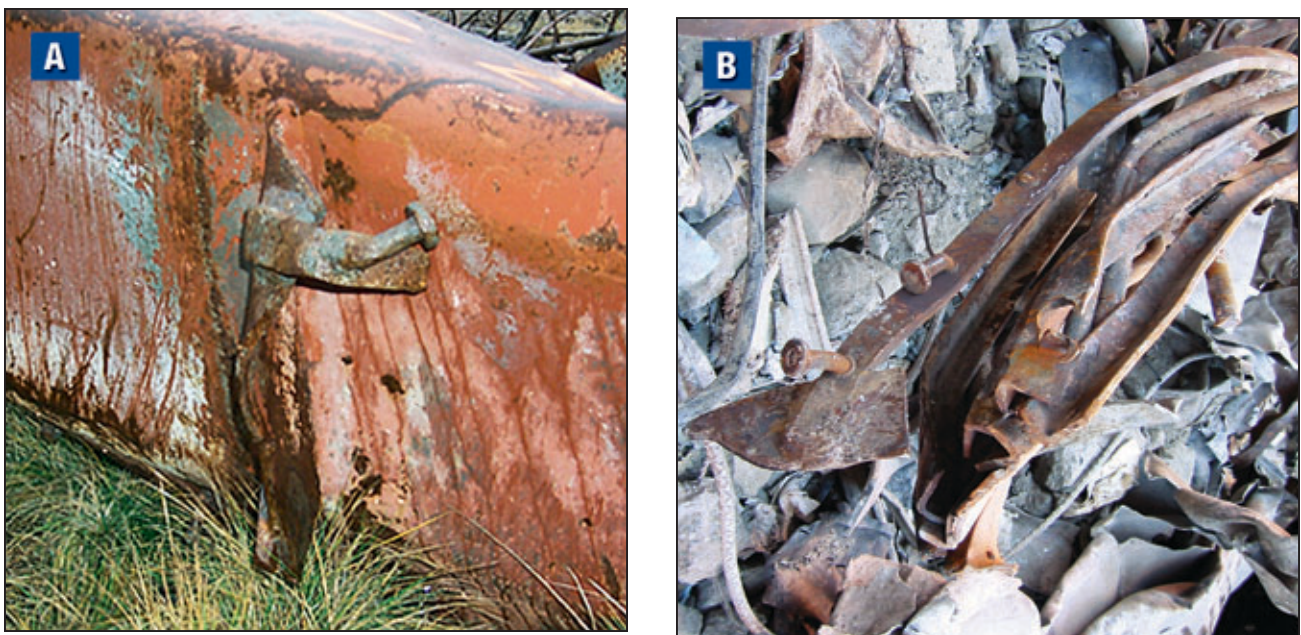
Figure B-10 (A) Bracket plate welded to the column/spandrel plate and (B) horizontal plate brace with shear connectors welded to the failed bracket.

It should also be noted that each truss top chord provided a horizontal diagonal plate brace (1-1/2 inches x 1/2 inch) to the two adjacent columns. These members were welded to welded bracket plates on each adjacent column/spandrel member, as illustrated in Figure B-10. In this case, it would appear that the diagonal plate braces fractured on their gross section or tore the bracket plate. The component of ultimate strength of the two diagonal plate braces normal to the column/spandrel member is about 85 percent of the tensile capacity of braces, which would be 76 kips.

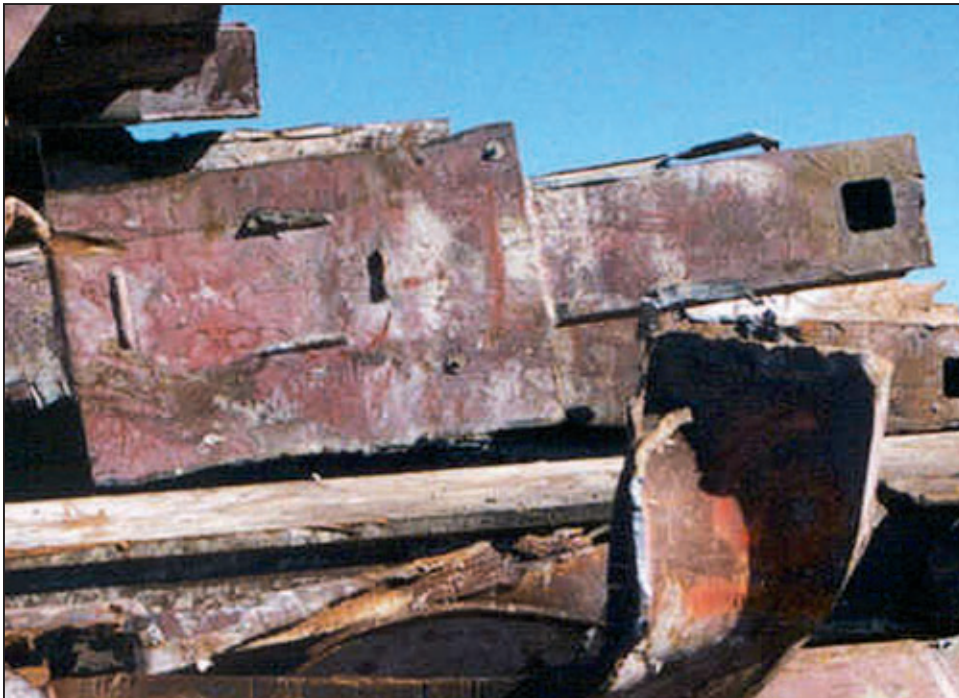
Figure B-11  
Shear failure of floor truss connections from column/spandrel plate.

Many of the bearing seat brackets and the damper angle connections on the column/spandrel beam plate were completely sheared off. Only the weld segments remained on face of the column/spandrel beam plate (Figure B-11). This mode of failure appears to be due to excessive vertical overloads on the floor system. This is in contrast with the failure mode exhibited in Figure B-9 where the bearing seat bracket has pulled away from the column/spandrel plate, after fracture of the top chord gusset plate.
